Instrument Tags

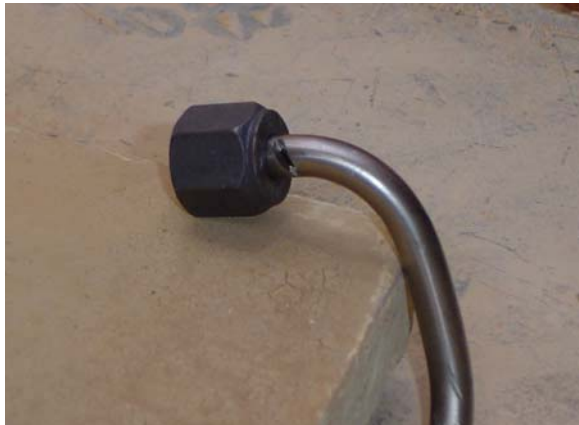
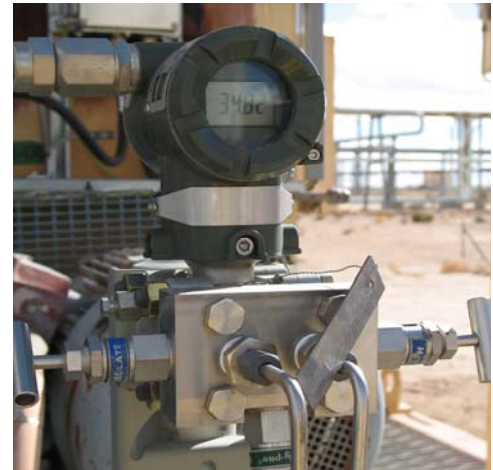
Over the last few weeks Moomba CHF#7 heater tripped about half a dozen times because of Main Burner Failure. The cause was eventually tracked to a hole in the combustion air flow transmitter impulse tubing. The damaged tubing is shown below, after removal from service. While the hole appears to have been made by a hacksaw blade, it was actually made by the stainless steel transmitter identification tag which was resting on the tubing, apparently for a considerable time (possibly since installation in late 2004)

This type of damage causes erratic behaviour of process control equipment and is hard to trace. In addition the damage reduces the structural integrity of the instrument tubing which could lead to a failure and release of process fluids or gases for lines operating at process pressures.

In both these cases the instrument lines are operating at very low pressure so there was little risk from the damage

Personnel are requested to inspect instrument tags as they move around Process and Production facilities. Where tags are found in contact with tubing, the tag is to be relocated by shortening the attaching wire or cable. Any tubing showing significant damage is to be replaced.

Engineering and Reliability will revise the relevant Santos Specifications to prevent a recurrence of this problem.

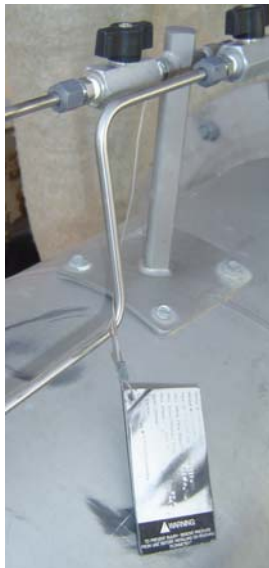
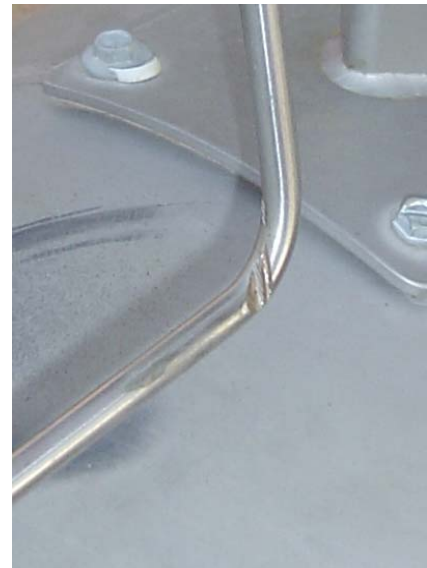
A similar problem caused this time by ~1mm stainless steel multi-strand cable attaching the ID tag to an annubar was also found on CHF #6.
