OGP Safety Alert

PIPELINE CONSTRUCTION/TRANSPORTATION FATALITY

Country: *CANADA - North America*

Incident Date: *1 December 2006 Time: ---*

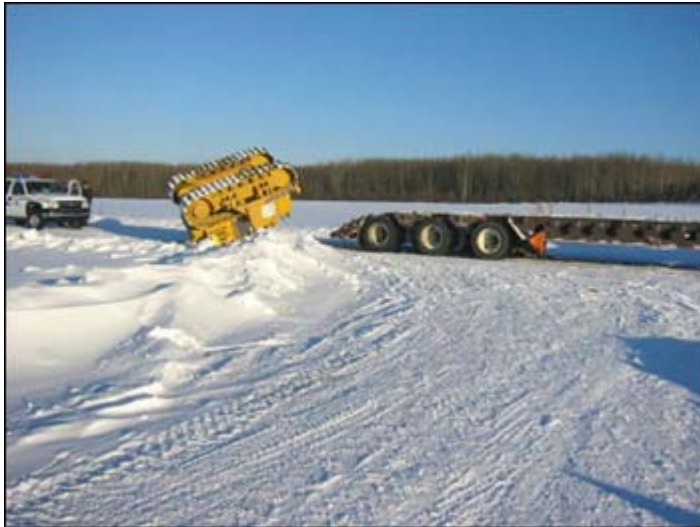
A truck driver had just arrived at location to deliver a pipe layer tractor. He unchained the pipe layer and had started moving the unit towards the trailer's beavertail. Eyewitnesses observed the pipe layer teetering, the driver suddenly standing up at the controls, followed by the machine shifting sideways appearing to lose control, then tumbling and overturning onto ground on the ditch side of the road, fatally injuring the driver who had unsuccessfully tried to jump clear from the tumbling machine.

- Improper Loading or Off-loading Practice(s)

- Inadequate Risk/Hazard Assessment of task

- The placement of pipe layer and trailer on slight incline; the physical and operational characteristics of the pipe layer; ice and debris on beaver tails.

1. Scissored down the lowboy and walked the pipe layer off the front of the trailer.
2. Used a winch tether combined with trailer to ground blocking for unloading the pipe layer using the trailer's beavertail.
3. Used a fixed ramp in conjunction with the trailer's beavertail (i.e., temporary earthen ramp).

1. Circulate a safety memorandum to all Owner's internal stakeholders requesting that all pipeline contractors currently working for the owner have written procedures for the loading and offloading of pipe layers and submit copies to Owner's Environmental Health & Safety (EH&S) Department.
2. Forward a safety alert to Enform with the recommendation that a Guide to Safe Work (GTSW) be mandated for loading and unloading of powered mobile equipment, specifically pipe layers.
3. Forward a safety flash to Canadian Energy Pipeline Association (CEPA), Canadian Association of Petroleum Producers (CAPP), Petroleum Services Association of Canada (PSAC), Alberta Construction Safety Association (ACSA) and Pipeline Contractors Association of Canada (PLCAC) for review by their membership and to poll support for an industry sanctioned GTSW.
