DBP SAFETYGRAM/HAZARD ALERT

DATE: 30/06/09	NUMBER OF PAGES: 1
DATE OF INCIDENT: 14/06/09	DOCUMENT NUMBER: DBNGP-SG-09-02

16" Rim failure to new Hilux Work Vehicles

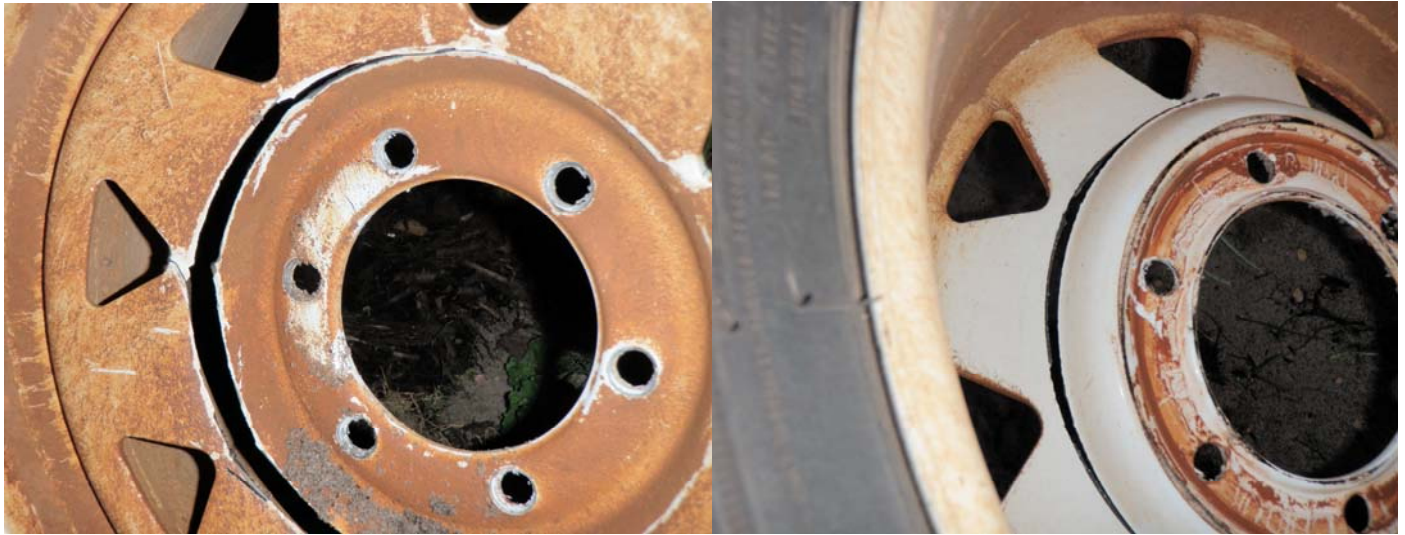
- The photos above show the failure of the rim at the pressed area just outside of the stud face.
- The photos also show that wheel stud area to be worn this is only the paint coming off and the locking area is in sound condition.

NOTE: The rims had recently been replaced with after market rims and had only been on the vehicle for one month.

Assumed poor manufacture of rim. Toyota Fleet Management has been notified and a response is still awaited.

The incident was reported immediately to the relevant supervisors and photos were taken. All rims have been inspected and other defects noted have resulted in the removal of the rims.
