DOCUMENT NUMBER: DBNGP-SG-10-02

Coating damage to the station inlet pipe

The fracture of a 2 inch utilities line

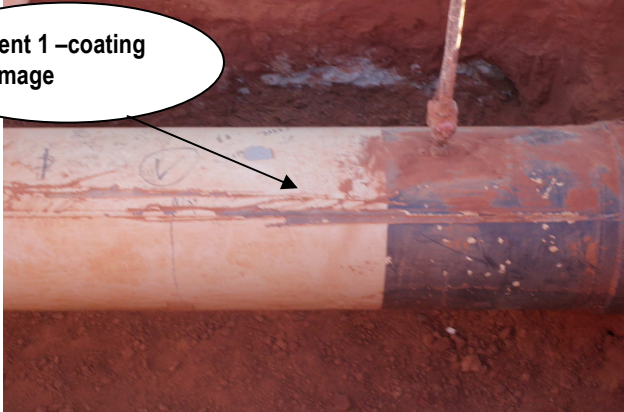
Event 1 –coating damage

- On Monday the 3/5/2010 an Excavator hit the station inlet pipe causing coating damage; and
- On Thursday 6/5/2010 at 12.30hrs an Excavator struck and fractured a 2 inch utilities line which resulted in a gas release.

Coating damage to the CS5 station inlet pipe and a fracture of a 2 inch utilities line, which resulted in an uncontrolled gas release. No one was injured. Both events resulted in mandatory reporting to the regulatory authorities. Although the extent of damage in both events was relatively minor the potential outcome could have been catastrophic in terms of lives lost and equipment damage.

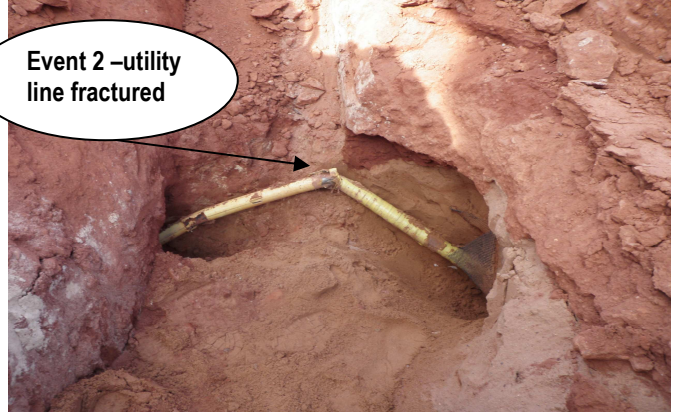
Event 2 –utility line fractured

- failure to adhere to the following business processes:
 - pre-planning phase;
 - work instructions for excavations; and
 - reporting incidents; particularly the failure to report and investigate the first event.
- and a culture existed where no-one stopped the job after:
 - hitting the pipe during the first incident ; and
 - identifying that planning was inadequate.

Local action taken: Following the 2nd event work was stopped, the event was reported, the work permit was cancelled, the site was made safe and an emergency was declared.
