DATE: 30/06/09	NUMBER OF PAGES: 1
DATE OF INCIDENT: 25/06/09	DOCUMENT NUMBER: DBNGP-SG-09-03

Hilux Work Vehicles involved in an Accident

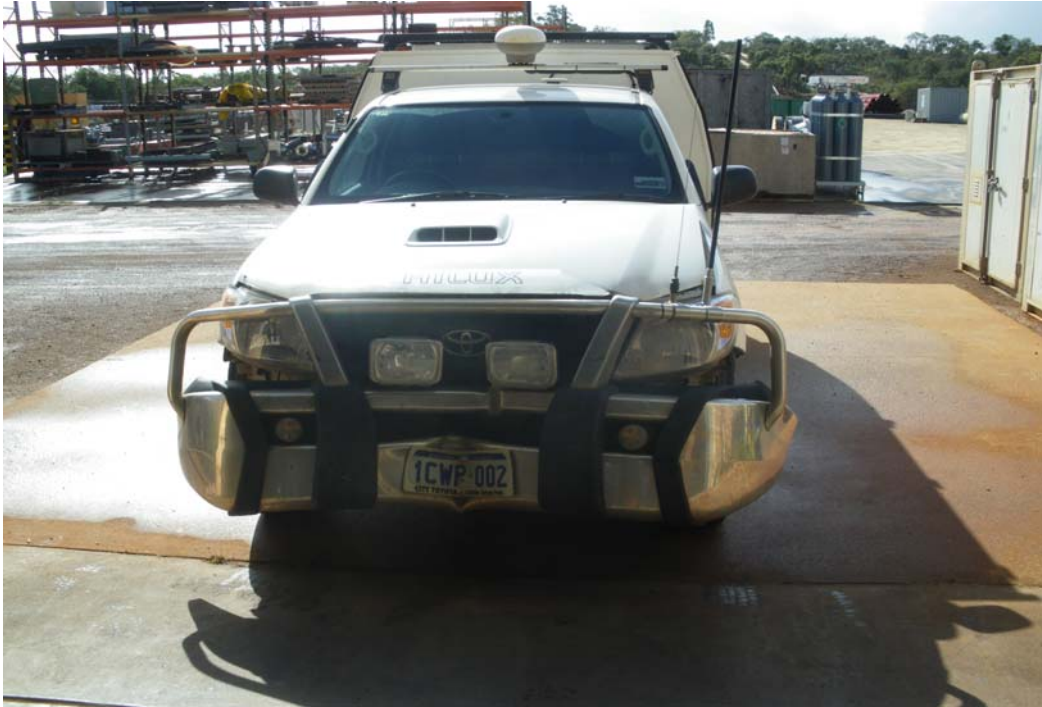
While driving to a course in Maddington, a work vehicle has accidentally run into the rear end of another work vehicle. This occurred in built up traffic in wet weather conditions. The vehicle travelling ahead of the other work vehicle braked heavily and turned right, the work vehicle following also applied the brakes heavily but was unable to stop and a collision occurred between the two vehicles.

There was no injury to personnel, however there was extensive damage to the vehicles involved.

Wet weather, traffic, personnel not allowing sufficient braking distance between vehicles and lack of awareness of surrounding traffic movements.

Personnel informed of the incident and precautions to be taken whilst driving in wet weather conditions.

The incident has been discussed at the end of roster Handover and will be discussed at the HSE Committee meeting to highlight the importance of the driving in wet weather conditions and taking extra care with the distance to ensure we can stop in time.
