DATE: 01 October 2009
DATE OF INCIDENT: 30 September 2009

NUMBER OF PAGES: 2
DOCUMENT NUMBER: DBNGP-SG-09-04

Load Bank Control Panel door locking mechanism caught on a 240VAC cable

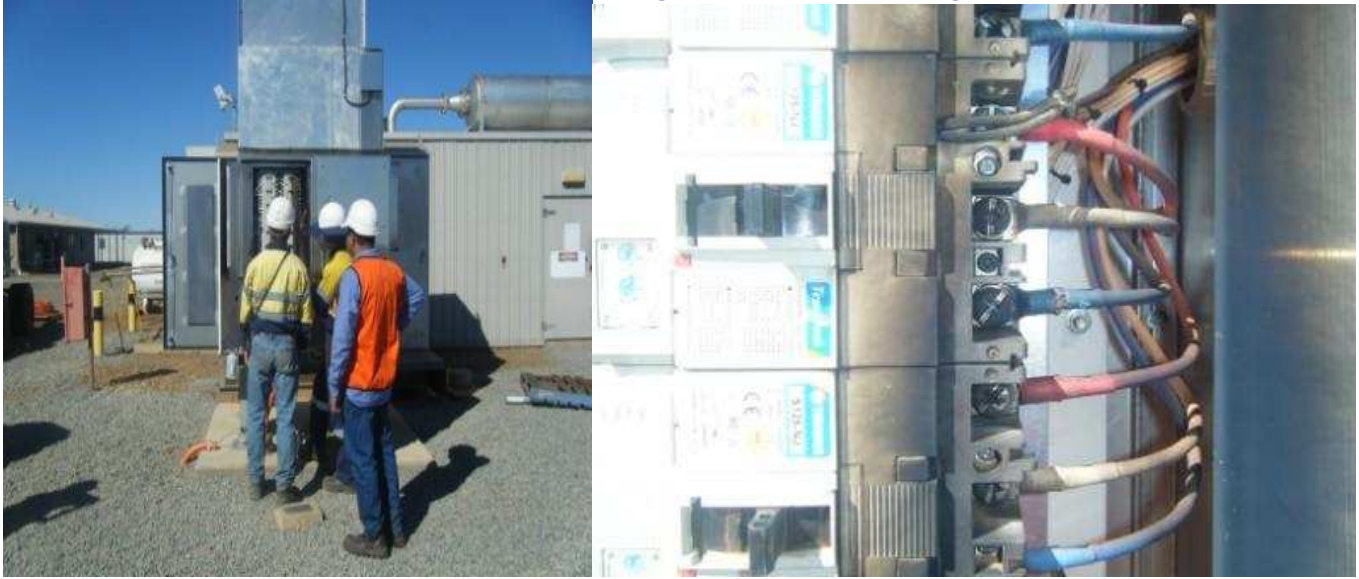
A preliminary investigation revealed that there was insufficient clearance between the middle recessed door locking mechanism and the blue phase wiring on one MCB. This led to the insulation on a 240VAC cable being caught and cut through causing a phase-to-earth short circuit via the Escutcheon plate. The earthing of the Load bank Control Panel caused the circuit breaker to trip and automatically remove power from the Load bank Control Panel.

Insufficient clearance between the locking mechanism and the cables within the Load Bank Control Panel.
The securing locking mechanism appears to be poorly designed allowing it to rotate past 90 degrees
The blue 240VAC cable may have been too long

- the subject Load bank Control Panel was immediately isolated and danger tags were installed per normal isolation procedures.
- the cause and mitigations were identified.
- the problem was corrected; recessing the cable that was initially caught by the door mechanism.
- the board was then re-energised.

All 5B Load banks at CS2, CS6 and CS7 will be isolated immediately. The load bank control panels will then be investigated to ensure that this problem will not recur; ie that the door latches have the clearance not to foul on the internal wiring loops
