SAFETY ALERT

Potential Safety Issues with the use of Hook Knives when removing Pipe Coating

While in the process of removing coating a worker received a laceration from the hook knife he was using to break the adhesion between the pipe and the tape

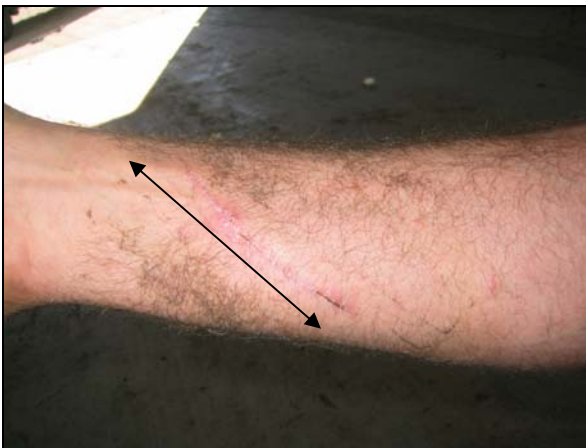
Length and location of the laceration

Inadequate guards/protective systems: The work process involved having to cut down on the tape to break the adhesion with the pipe which left the workers opposite arm exposed. The personal protective clothing was insufficient to stop the knife blade from cutting through the shirt sleeve.

1. Review the incident with all crew and highlight the importance of stepping back and assessing the task at hand and appropriate planning.
2. Revise the JHA for Coating to incorporate the management of the hazards associated with conducting repairs and adhesion testing, with consideration of risk controls to include:
 - The use of hook or alternate knives in the application;
 - Incorporating the use of additional PPE ie. Chainmail or leather gauntlets;
 - The potential of using two men to carry out the task; and
 - A review of the current technique.
3. Investigate the feasibility of using knives with spring-loaded retractable blades.

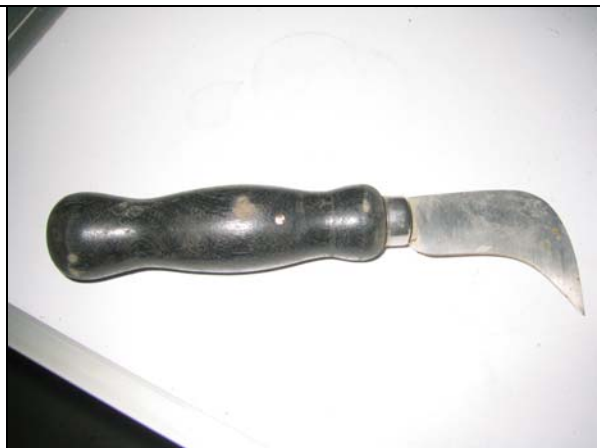
Hook Knife

Haste/Improper speed: As a result of the rework and the slow progress the other crew were making the worker believes that he carried out the task with a degree of haste.

Inadequate Work Standard: The JHA for Joint Coating - does not address the hazards associated with tape removal for conducting repairs and adhesion testing activities.
