# SAFETY BULLETIN

## Human interaction with backhoes and excavators

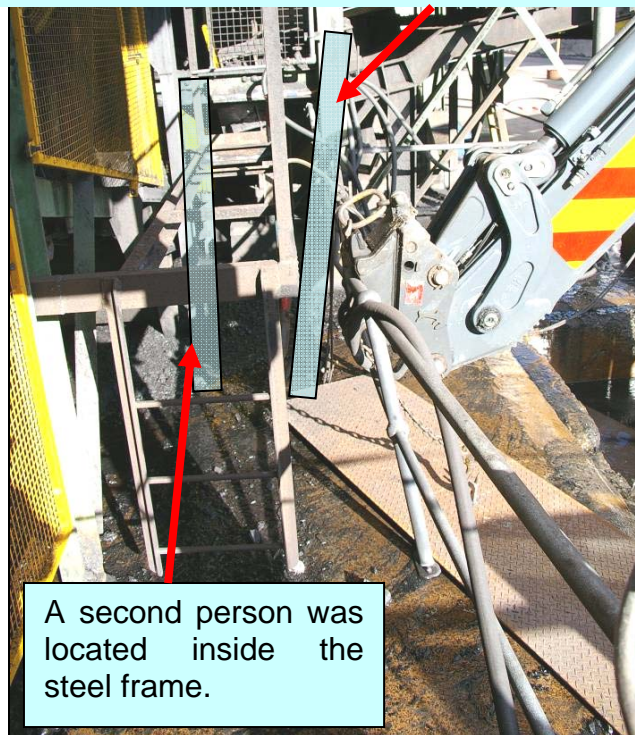
Injured person had entered into the work zone and was positioned between two steel structures. The person was crushed between the railing forced by the backhoe arm and the fixed steel structure. The backhoe operator was not aware of the location of the injured person due to the raised backhoe arm.

A second person was located inside the steel frame.

- a. Remove the offsider from the work zone of an excavator or backhoe.
- b. Place hard barrier controls to prevent an offsider from entering the work zone without the machine operator being fully aware of the intent to enter.

- a. When handling pipes and logs provide guarding for cabin windows.
- b. Proximity detection to warn the machine operator of persons and equipment around machines has been trialled at several NSW and Queensland mining operations. It is reasonably practicable to use proximity detection technology to warn an operator of the unintended presence of a person in the work zone of a backhoe or excavator.

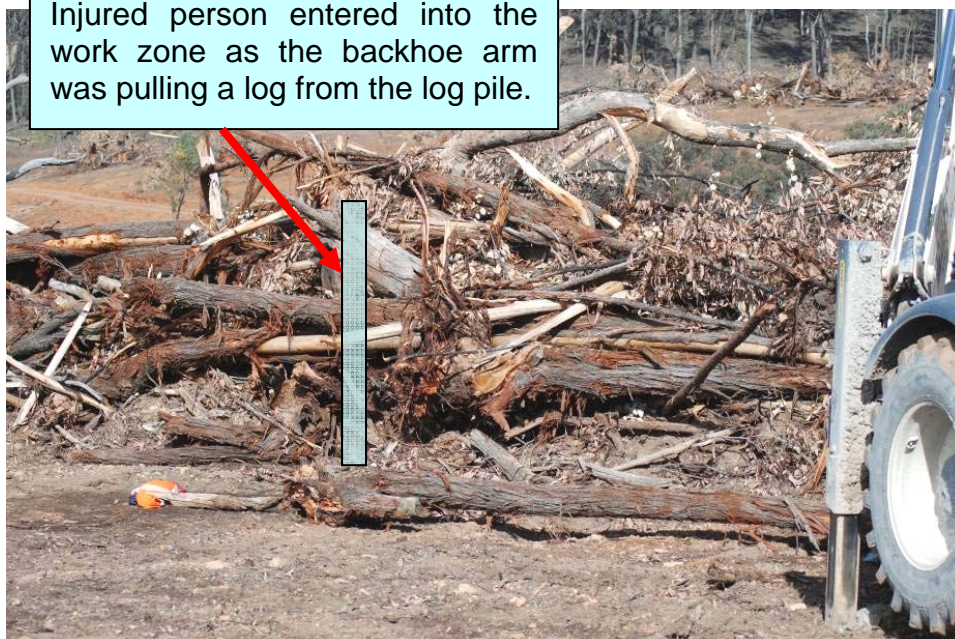
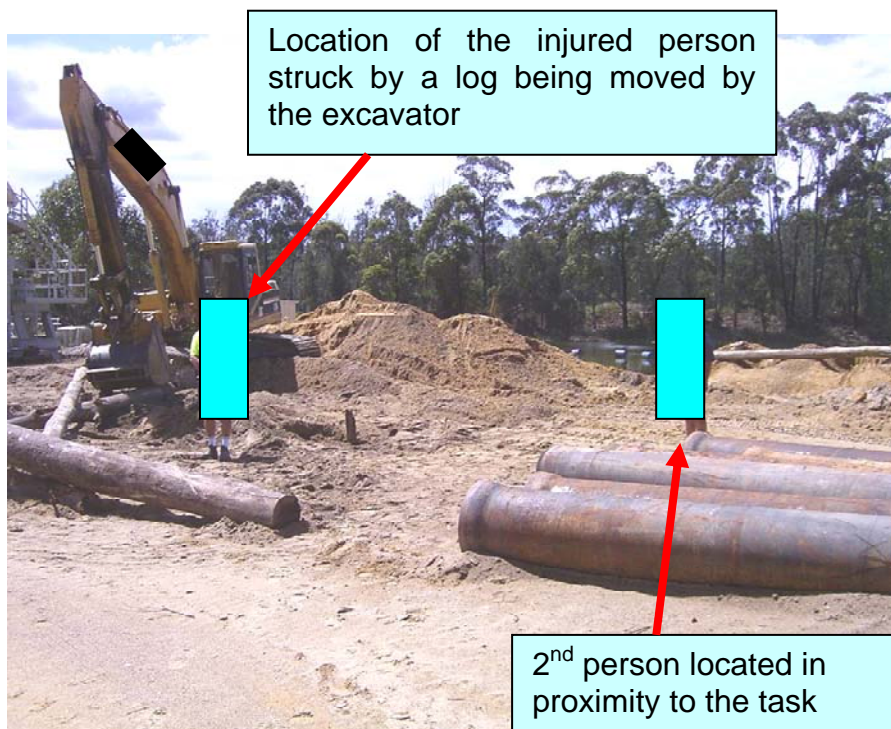
Injured person entered into the work zone as the backhoe arm was pulling a log from the log pile.

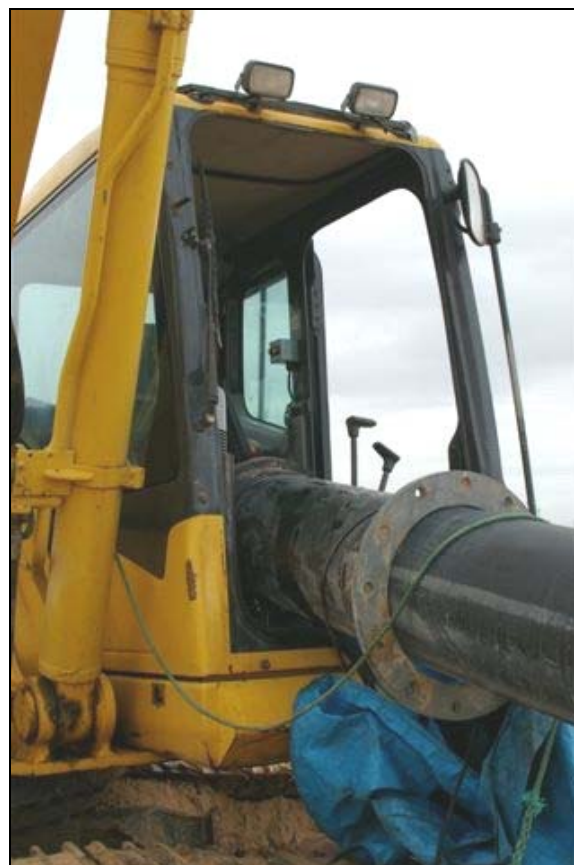
The following photograph was taken following an incident involving lifting and dragging a 12 metre length of polyethylene pipe weighing approximately 600kg by an excavator. The pipe slipped through the supporting chains and entered the operator's cabin, striking the operator and resulting in injury.

- a. Substitute the method of controlling the load instead of reliance on hands-on human interaction with the load, e.g. use tag lines.
- b. Substitute the risk in consultation with engineering advice to ensure lifting and pulling equipment is used within its rated capacity.
- c. Substitute in consultation with the appropriate OEM fit-for-purpose equipment suitable for the task, e.g. use of log grab and pipe handling devices.
