Petroleum and Gas Inspectorate

Safety Alert No. 43
21 September 2009

Broken leg from coal seam gas sampling incident involving high pressure.

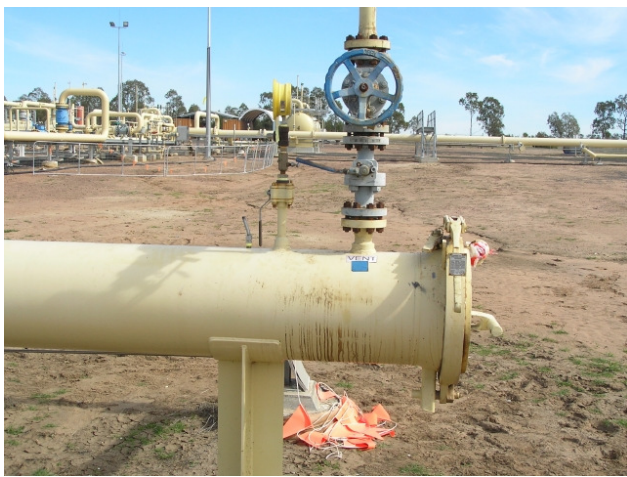
A gas sampling contractor was struck by a flying fragment from an exploded gas filter. The filter had been exposed to a pressure that exceeded its design specifications (1,600kPa). The filter was being used as part of a gas sampling kit on the high pressure (9,000kPa) product end of a coal seam gas processing plant. One of the contractor technicians undertaking the work sustained a broken leg and related soft tissue damage.

Pig receiver and sampling point

- Gas sampling connection and disconnection procedures to include requirements for correct sequence of events and specify the type and rating of components that form the sampling kit.
- Dedicated sampling point to be provided if regular sampling is a standard requirement at the facility.
- Organisations to immediately review their:
 - Hazard registers
 - Risk assessments
 - Standard operating procedures (SOPs)
 - Job safety analyses (JSAs)
 - Contractor training and supervision requirements.

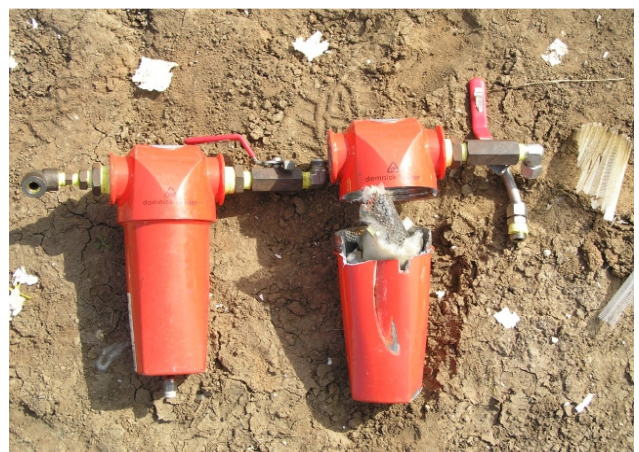
- Incorrect selection of filter type for the application.
- Contractors had no formal training in high pressure sampling and had not directly undertaken work before.
- Lack of risk assessment, identification of hazards and use of standard operating procedures when taking gas samples.
- Poor implementation and adherence to existing:

Damaged filter
